Archeological Investigations at
Burcher Cottage
Colonial National Historical Park
Yorktown, Virginia

Allen H. Cooper
1997

MANAGEMENT SUMMARY

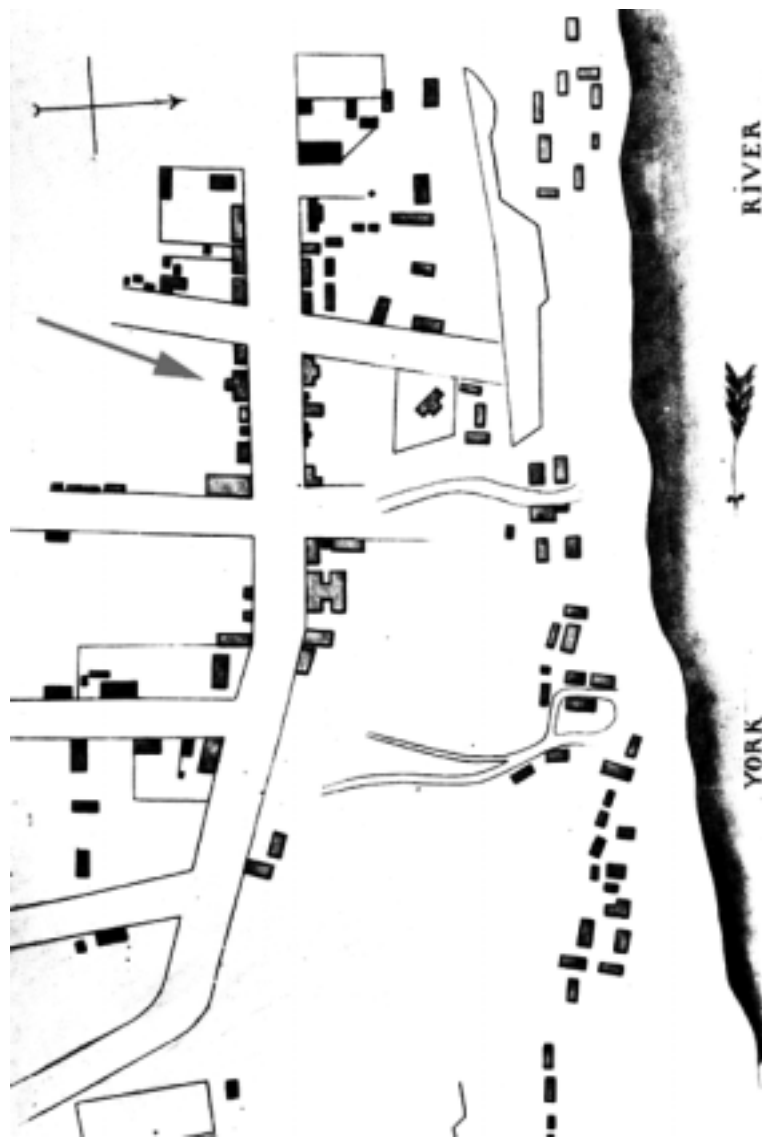
Figure 2: Detail from the Berthier billeting plan of Yorktown, 1781 showing "T-shaped" structure on Lot 37 indicated by red arrow (Berthier 1781 from Hatch 1980: 193).

Archeological monitoring of interior restoration revealed the presence of brick footings for an early structure, possibly the "T-shaped" building shown on the 1781 billeting plan for Yorktown. Monitoring of the initial drain line to the west and south revealed an extensive fill deposit which was archeologically tested prior to extension of the drain line. This excavation revealed that the midden deposit contained intact refuse deposits that are probably associated with occupation of the structure. Because this structure may represent an "ordinary" or tavern (a site type unrepresented at Yorktown) and has intact associated midden deposits, the site represents a significant resource for the understanding of daily public life in the mid-eighteenth century town, and contributes to the National Register eligibility of the park. Installation of the drain extension impacted the later fill deposits that overlay the midden and did not effect the Register properties of the site.

3. Historic accounts suggest that the recently discovered foundation may in fact be the remnants of the "T-shaped" building once located in the center of Lot 37 (the lot where the Burcher Cottage currently stands. See Charles E. Hatch, Jr., Editor, Colonial Yorktown's Main Street, 1980, pp. 657-69). We know from the Berthier map that this structure was standing during the siege of Yorktown. Further historical evidence is needed to ascertain how long it survived subsequent to its late eighteenth century existence. Architectural historians believe the Burcher Cottage to date from about 1870. Certainly the range of artifacts observed in the destruction level suggest a date range of 1770 or so to about 1850-60. A preliminary hypothesis might suggest that this indicates that the "T-shaped" building survived in some form until that time. However, a complete land use history of Lot 37 probably should be done.

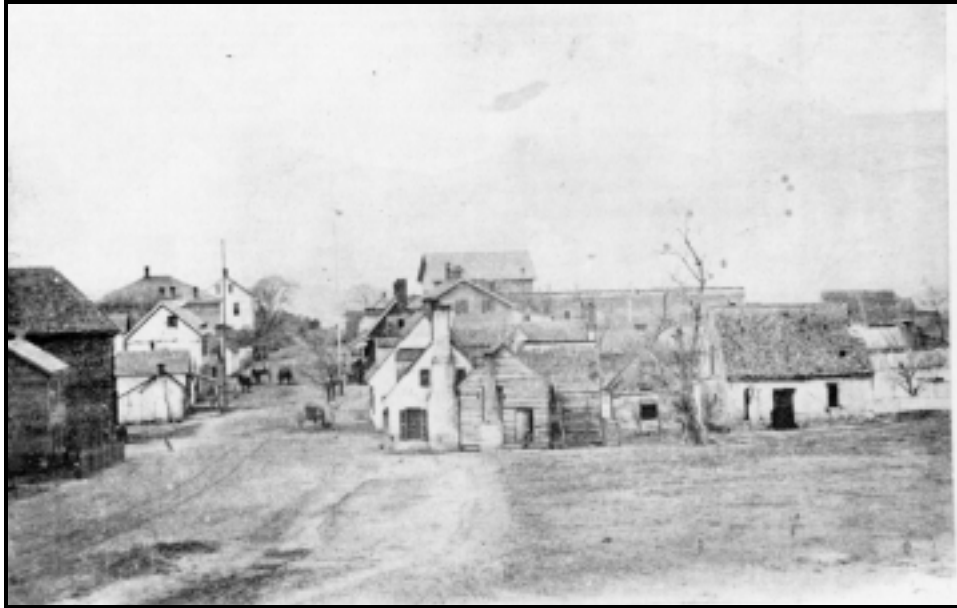
Figure 3: Photograph of Main Street in the late 1870's (From Hatch 1980: 207). Burcher Cottage appears left of center.

Burcher Cottage is located on Lot 37 in Yorktown, Virginia, now part of Colonial National Historical Park (Figure 1). Lot 37 has been occupied since 1682 by a succession of structures, the first building on the lot was an ordinary or tavern (Hatch 1980:67). By 1715, the lot contained one messuage and two cottages (Ibid:68). By 1781 the lot contained two large structures, a "tee-shaped" structure on the location of the present Burcher Cottage, and a large structure to the east (Figure 2). The foundation of the "tee-shaped" structure was discovered during rehabilitation of the Burcher Cottage in 1992 (Orr 1992; Appendix 1). Absent during the Civil War, the Burcher Cottage appears by the 1870's with two frame outbuildings to its east (Figure 3). By 1931, the two outbuildings were replaced by a two-story Greek Revival frame house, oriented with its gable end facing Main Street (Figure 4) which in turn was demolished by the National Park Service in the 1930's.

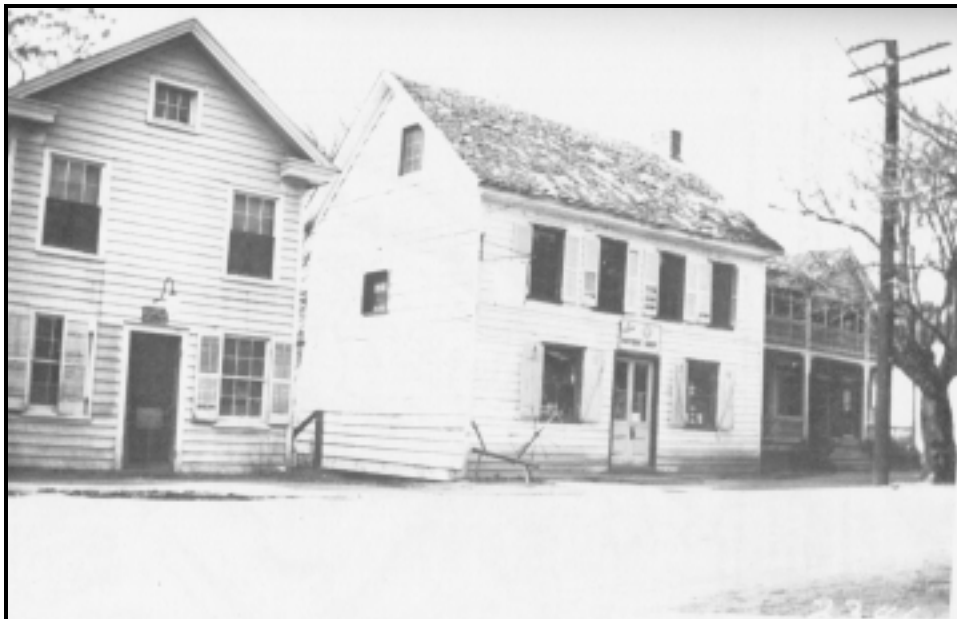
Figure 4: Photograph of Burcher Cottage in 1931 (From Hatch 1980:219).

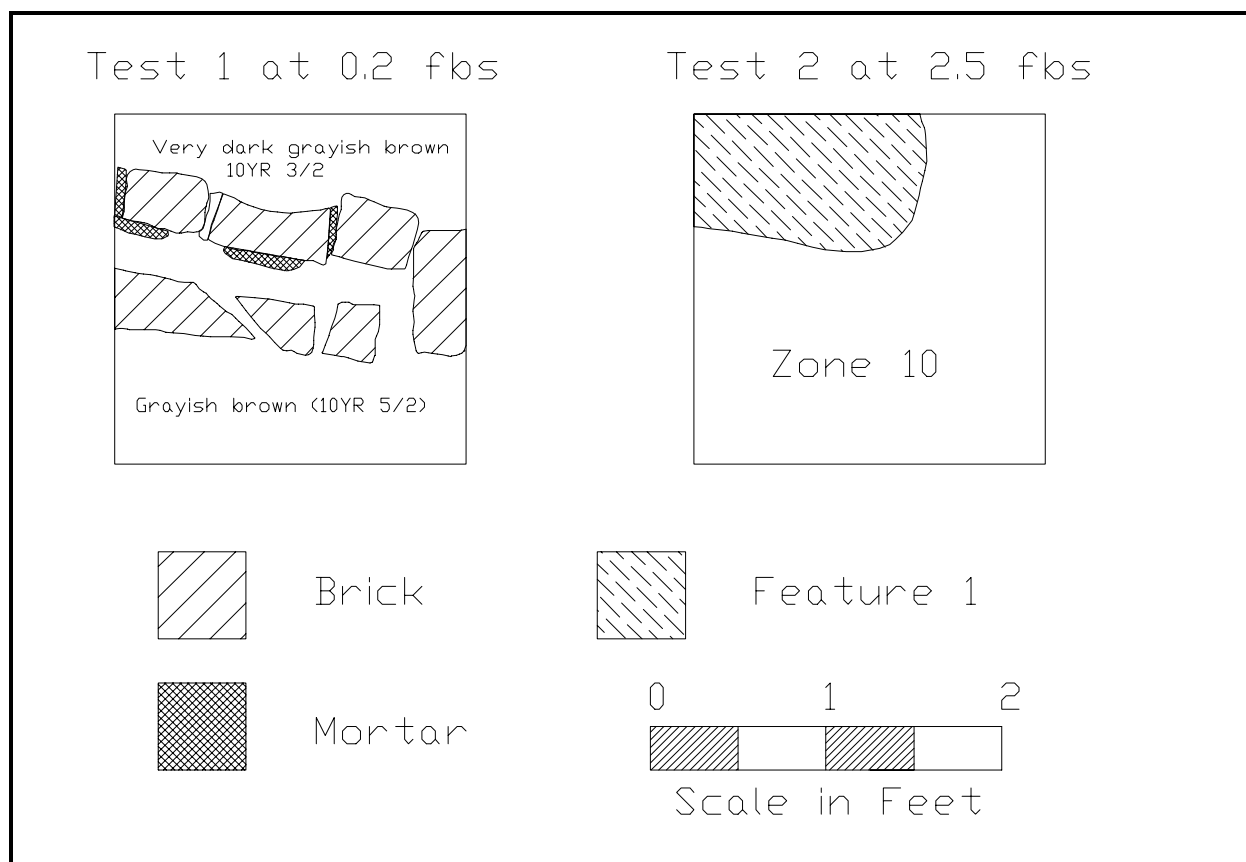
Figure 6: Plan views of Test 1 and Test 2 Feature 1.

Zone 8 extended from 2.5 to 2.7 feet below surface and was defined by brown (Munsell color 10 YR 5/3) sandy loam. It contained Feature 1 (Figure 6) that contained fill similar to Zone 7 and represents a posthole originating from the deposition of that stratum. It contained a kaolin pipe stem fragment measuring 5/64" diameter and fragments of cut nails. Zone 9 began at 2.7 feet below surface across the entire unit. Composed of very dark grayish brown (Munsell color 10YR 3/2) humic sandy loam containing charcoal flecks and occasional brick fragments, it extended to 3.0 feet below surface and contained a variety of mid-eighteenth century ceramics. It also contained a single fragment of whiteware which is believed to have been introduced to this zone by the excavation process.

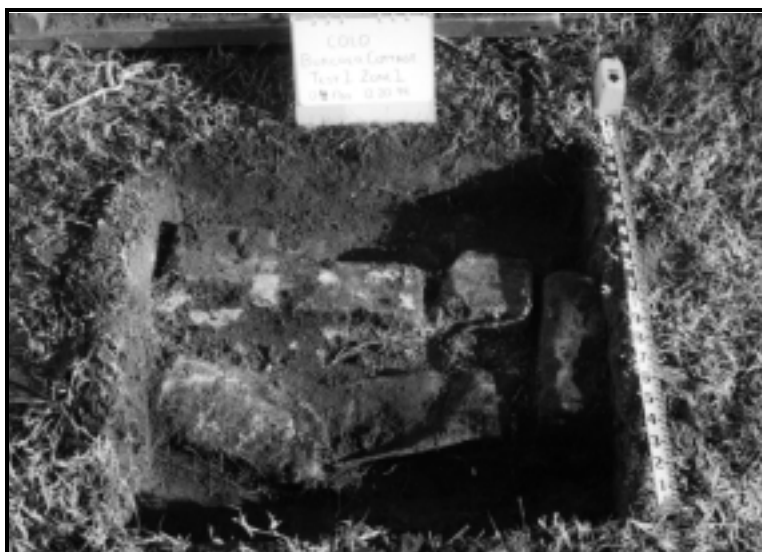
Figure 7: Test 1 (0.2 fbs).

Test 1: Test 1 was located seven feet south of the existing end of the Burcher Cottage drain. Located as to expose the below-ground portion of a surface-visible foundation remnant of the structure removed in the 1930's, the test revealed that the foundation, although slightly displaced, was relatively intact. The foundation is two stretcher courses wide with sand-lime mortar joints (Figures 6 and 7). Most bricks appear well-fired and finely tempered with re-use of a glazed stretcher.

At 0.4 feet below surface where the excavation was suspended, the foundation continued with stratigraphic separation between the areas north and south of the foundation; north of the foundation contains very dark grayish brown (Munsell color 10YR 3/2) sandy humic loam containing bits of orange clay while south of the foundation the soil is grayish brown (Munsell color 10 YR 5/2) sandy humic loam. The north area is most likely a builder's trench or interior deposits associated with demolition of the structure appearing in the 1930's photograph of Main Street (Figure 4). Excavation was temporarily suspended at this depth to investigate the undisturbed adjacent units to determine if significant intact strata appeared above the proposed depth of disturbance. Upon excavation of the adjacent units, it was evident that the foundation and the adjacent strata post-dated the middle of the nineteenth century and did not contribute to the park's Register eligibility. Monitoring of construction confirmed this finding.

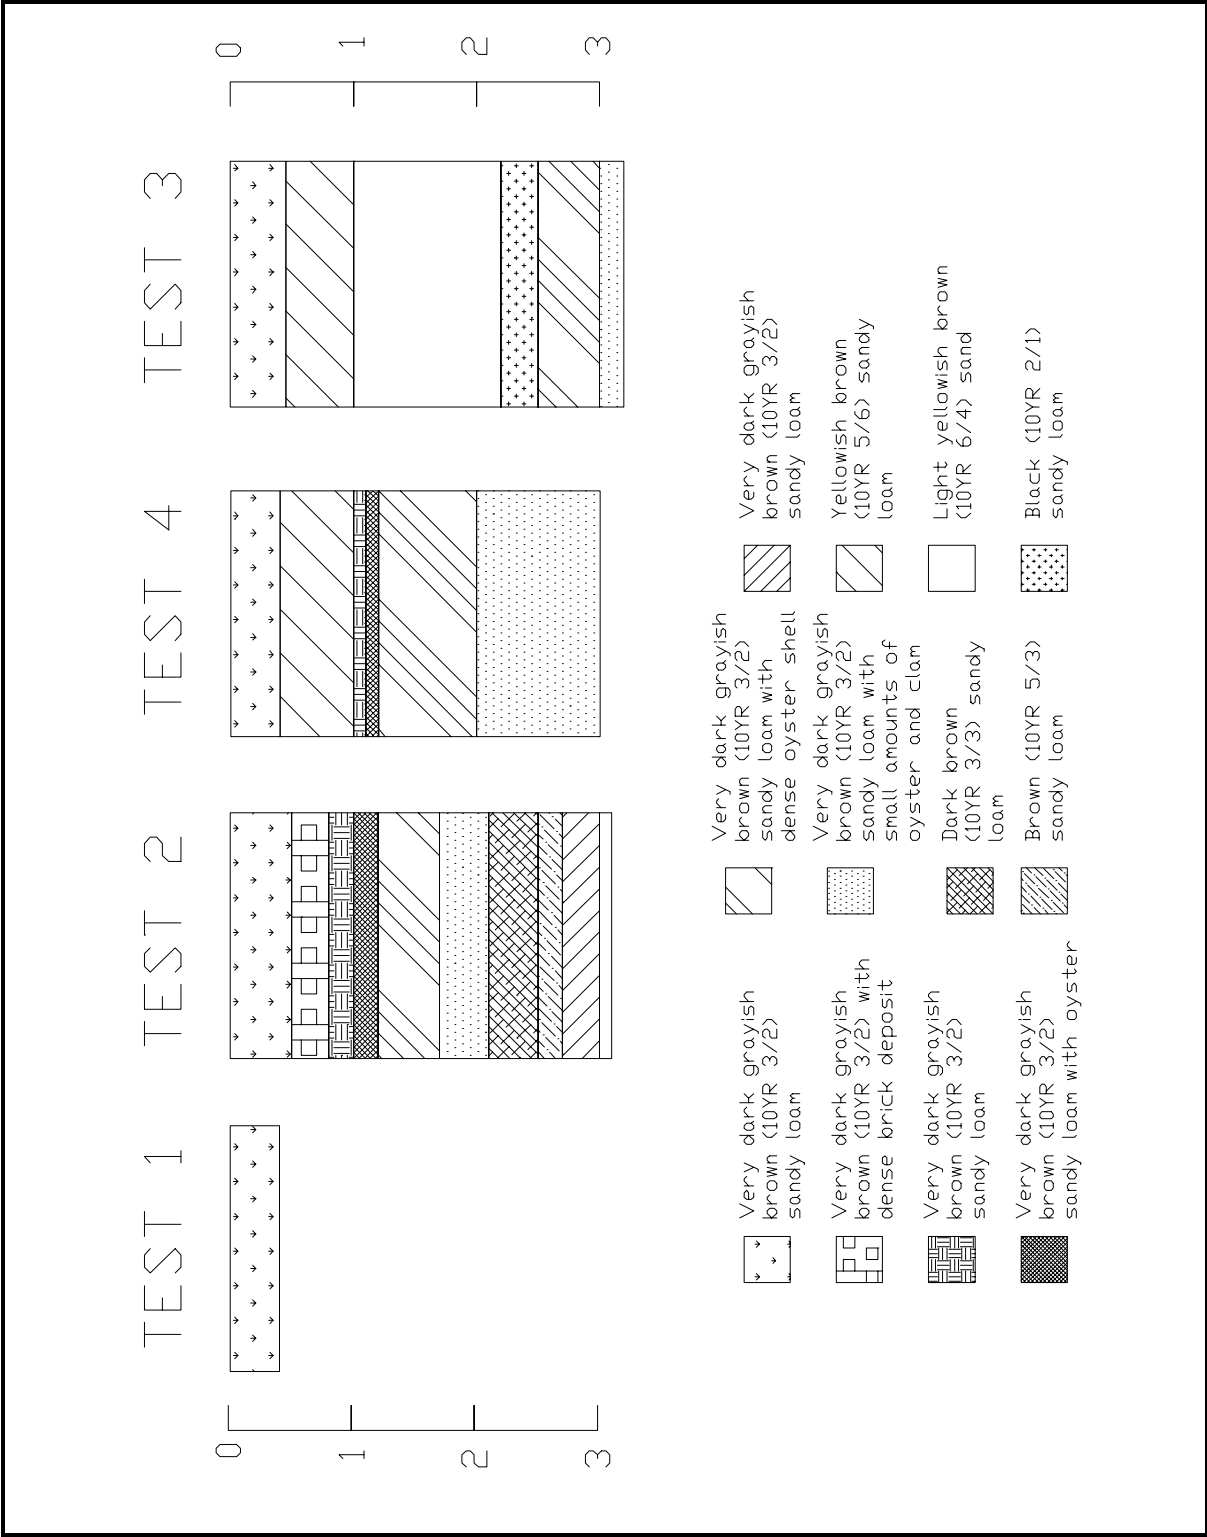
Figure 10: North profile drawings of Tests 1, 2, 3, and 4.

Test 3: Test 3 was located 20' south of Test 2 within fifteen feet of the edge of the terrace's southern margin. Zones 1 through 3 are recent fill deposits dating from the 1930's, and possibly later (Figures 8 and 10). Zone 1 was defined as very dark grayish brown (Munsell color 10YR 3/2) sandy loam from the surface to 0.45 feet below surface with a modern date of deposition. Zone 2 was defined as yellowish brown (Munsell color 10YR 5/6) sandy loam extending from 0.45 to 1.0 feet below surface. Zones 1 and 2 were not screened, however no artifacts were observed in their excavation. Zone 3 was defined as light yellowish brown (Munsell color 10 YR 6/4) sand with worm and root mottles extending to 2.2 feet below surface. Having no artifacts, it was an obvious layer of modern sand fill.

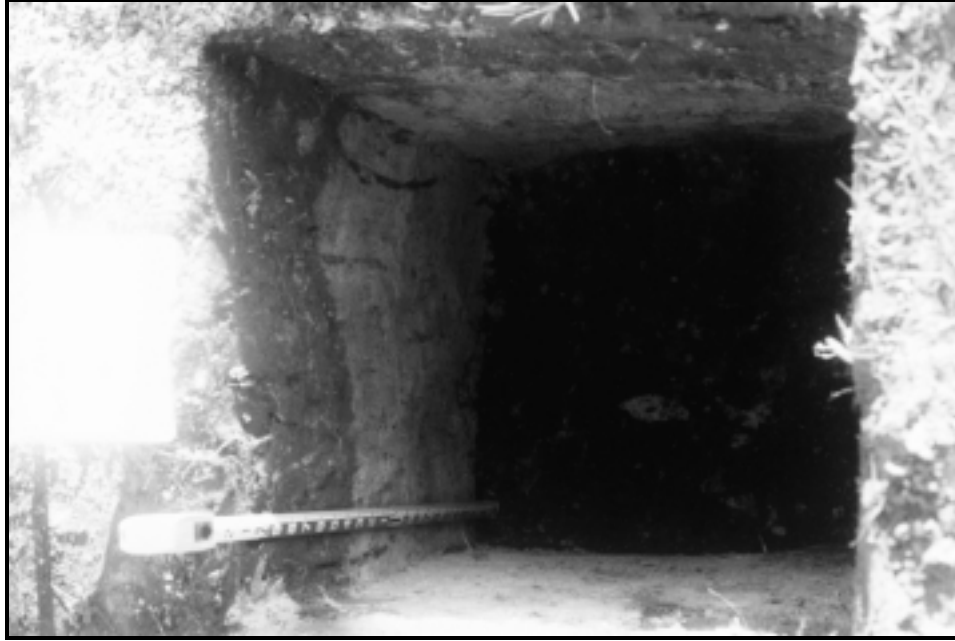
Figure 9: Photograph of Test 3 north profile.

Zone 4 was defined as black (Munsell color 10YR 2/1) sandy loam containing wire nails, whiteware, amber glass, etc. extending from 2.1 to 2.5 feet below surface across the entire unit. This stratum represents the modern occupation of the site. Immediately beneath this was Zone 5, corresponding exactly with Zone 5 in Test 2 and containing very dark grayish brown (Munsell color 10YR 3/2) sandy humic loam with dense concentrations of oyster shell. Zone 5 extended to 3.0 feet below surface. Zone 6 began at 3.0 feet below surface and was defined as very dark grayish brown (Munsell color 10YR 3/2) sandy organic loam containing small quantities of oyster and clam shell, brick fragments, etc. Zone 6 contained mid to late nineteenth century artifacts and is the same stratum as Zone 6 in Test 2. Excavation of Test 3 was suspended at 3.0 fbs, in excess of the proposed construction disturbance.

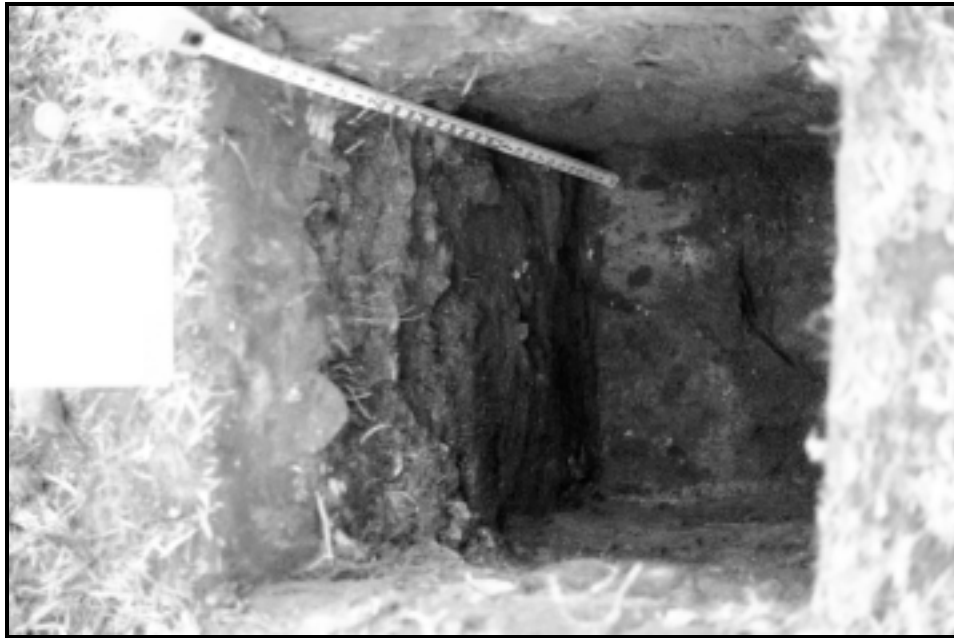
Figure 10: Photograph of Test 2, north profile.

Stratigraphically, Unit 2 opens with very dark grayish brown (Munsell color 10YR 3/2) sandy humic loam from the surface to approximately 0.5 feet below surface where it somewhat arbitrarily ends (Figures 8 and 9). Zone 1 artifacts include manganese glass, whiteware, and cut nails, indicating a

modern provenance. Zone 2 contained very dark grayish brown (Munsell color 10YR 3/2) sandy humic soil containing rather dense deposits of displaced (vertically jumbled) brick and mortar fragments.

Zone 2 also contained relatively modern artifacts including a bottle base marked "PATENT 1897". Zone 3 began at 0.8 feet across the entire unit. Composed of mottled sand (pale brown (Munsell color 10 YR 6/3) and very dark grayish brown (Munsell color 10YR 3/2)) it contained at its top, artifacts pushed down from Zone 2 during demolition of the Greek Revival structure. It contained a mixture of late nineteenth century and some twentieth century artifacts (galvanized flashing). Zone 3 ends at 1.0 feet below surface. Zone 4 consisted of very dark grayish brown (Munsell color 10YR 3/2) sandy organic loam with no visible brick but with nineteenth century glass fragments and oyster shell. It represents the 1930's pre-demolition ground surface. Zone 4 is 0.2 foot thick.

Zone 5 began at 1.2 feet below surface (fbs) and consists of variegated orange and brown coarse sand containing dense concentrations of oyster shell and clam shell. Occasional artifacts (transfer printed whiteware) indicate a mid-nineteenth century or later date. It was this stratum, identified during the monitoring of the original drain, which precipitated this testing program. It represents a massive filling episode associated with the construction of the Greek Revival structure prior to 1930 (Figure 4). Zone 5 continued to 1.7' across the entire unit. Zone 6 was defined as very dark grayish brown (Munsell color 10YR 3/2) coarse sandy loam containing moderate amounts of oyster and clam shell, wire and cut nails, whiteware and earlier ceramics (Table 1) from 1.7 to 2.1 feet below surface. This zone represents the accumulation of debris from removal of the nineteenth century structures and the period in which no structures are documented for the site throughout the Civil War and into the 1860's (as evidenced by the wire nails). The absence of an intact stratum

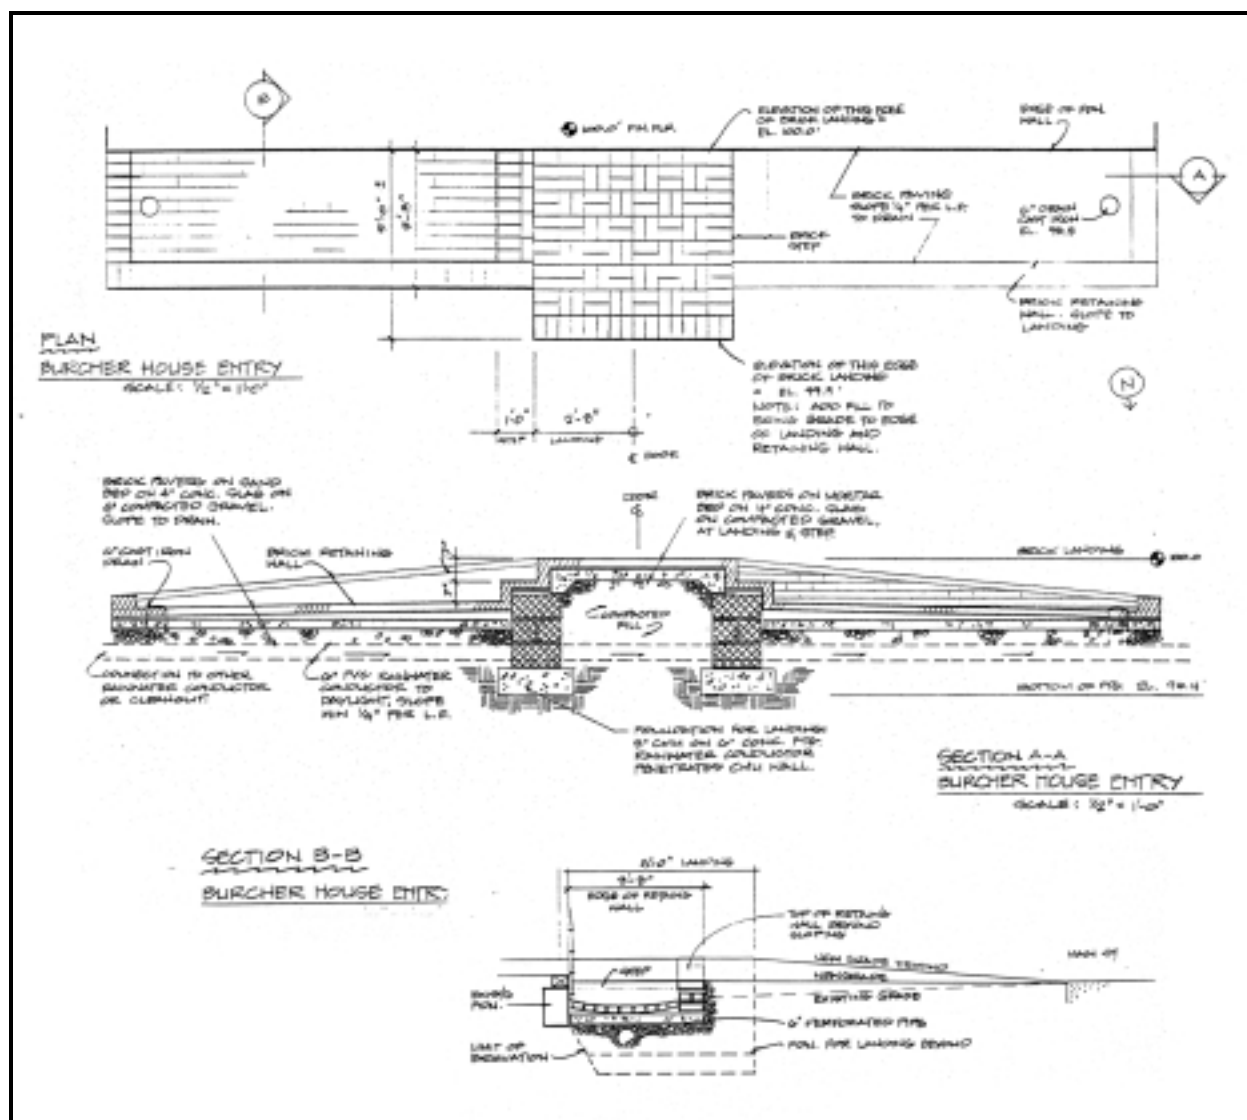
Figure 11: Architectural drawings for north facade drainage improvements.

Archeological monitoring of the drainage improvements along the north facade of Burcher Cottage (Figure 11) indicated that the area had been heavily modified by utility construction, evidenced by an abandoned main telephone cable. The north profile exposed during construction is presented in Figures 12 and 13.

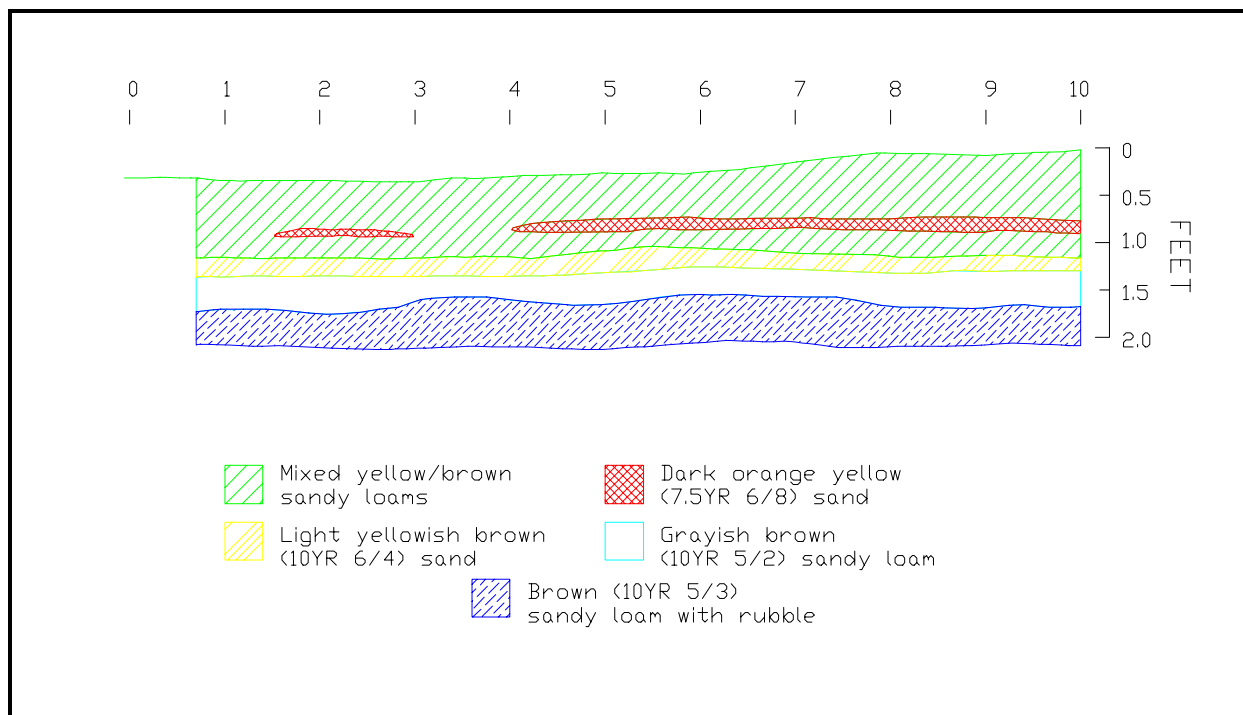
Figure 12: Drawing of north profile, north facade drainage improvements.

Stratigraphy within the exposed profile consisted of heavily mixed yellow/brown soils interspersed with lenses of dark orange yellow sand from the surface to 0.8 fbs. This stratum represents subsequent grading and filling for Main Street. Beneath this lay a thin (>0.2 feet thick) layer of light yellowish brown (Munsell color 10YR 6/4) sand which in turn overlay a thicker (0.4 feet thick) layer of grayish brown (Munsell color 10YR 5/2) sandy loam. These strata covered a thick (0.5 feet thick) layer of demolition debris containing loose brick (but no other artifacts). The latter stratum also contained an abandoned main telephone cable that paralleled Main Street. It was impossible to conclusively determine if the telephone cable was the primary agent for disturbance in the area, or if had been installed in a previously disturbed area. The latter appears somewhat more likely.
